Subjects: Dock and Sea Trials "RTA 1" Catamaran Passenger Ferry
Metal Shark Franklin, LA.

The following was observed during my visit of April 27, 2018

First Catamaran Ferry "RTA 1"

Two (2) 32.0 (m) X 7.7 (m) X 1.35(m)RTA Passenger Ferries

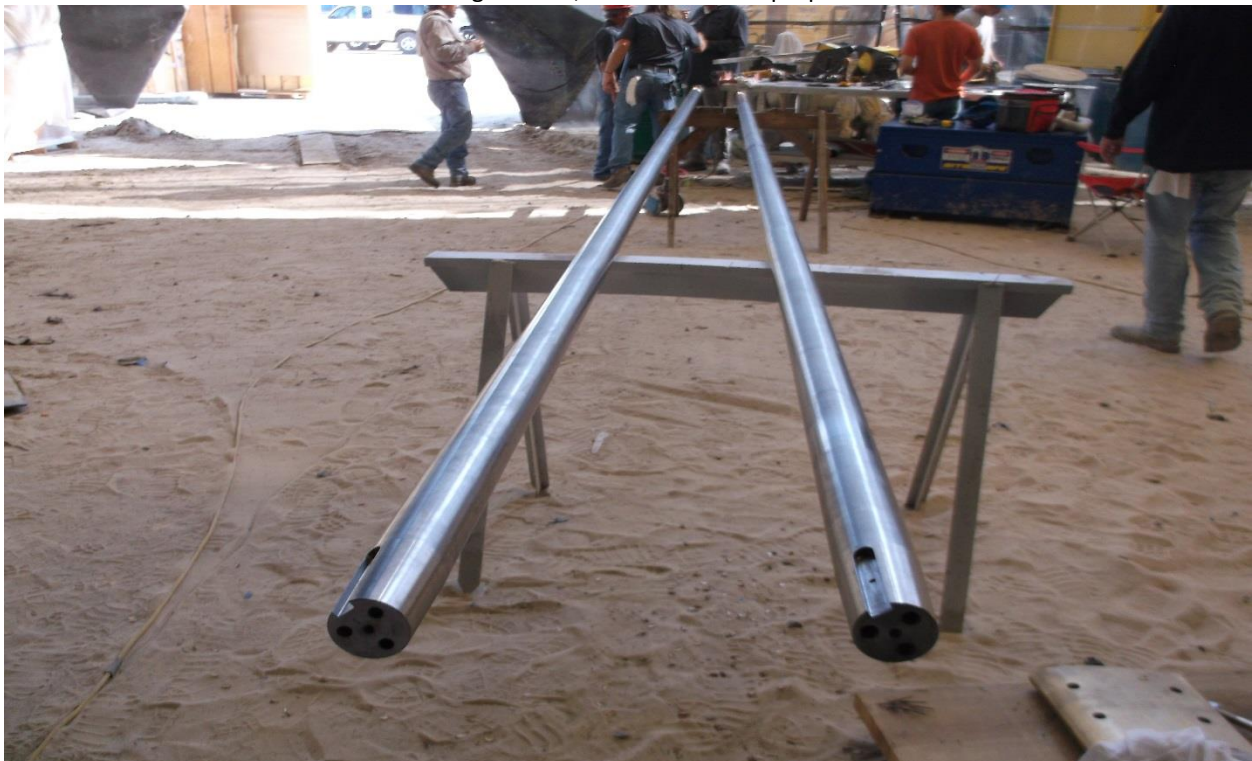
Views of steering rudders, shaft collars and propulsion shafts

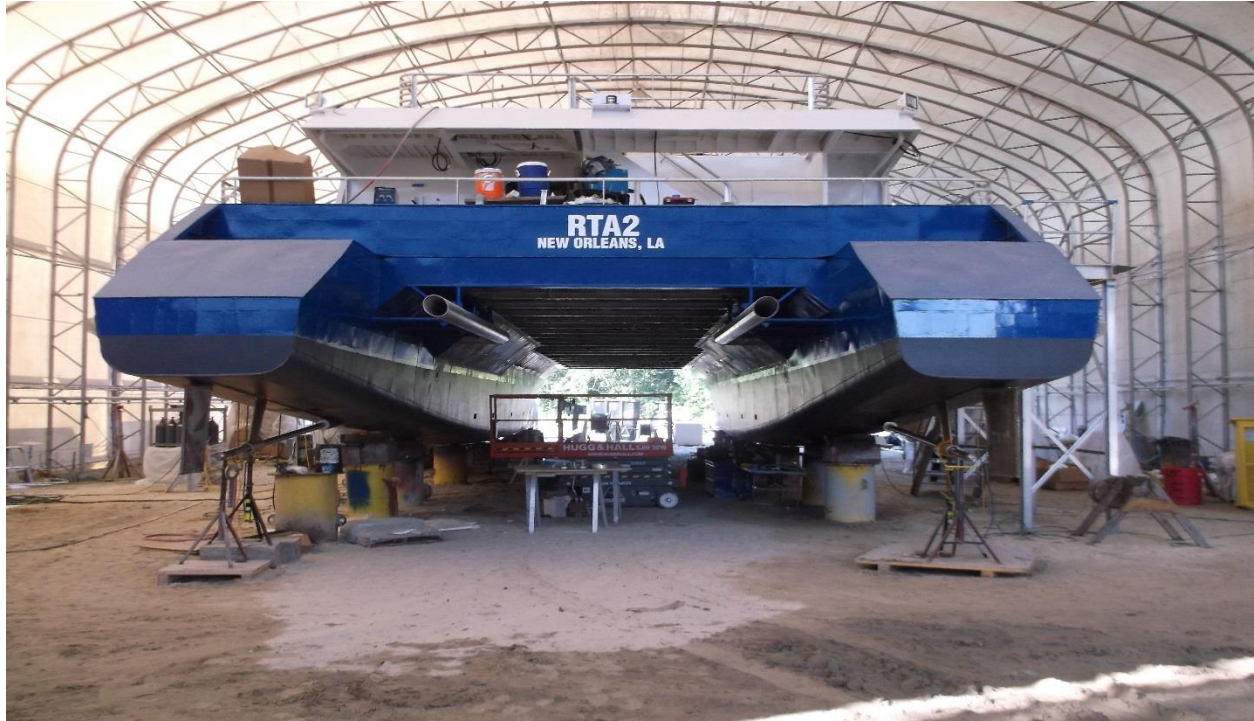
Stern view having shafts and rudders installed

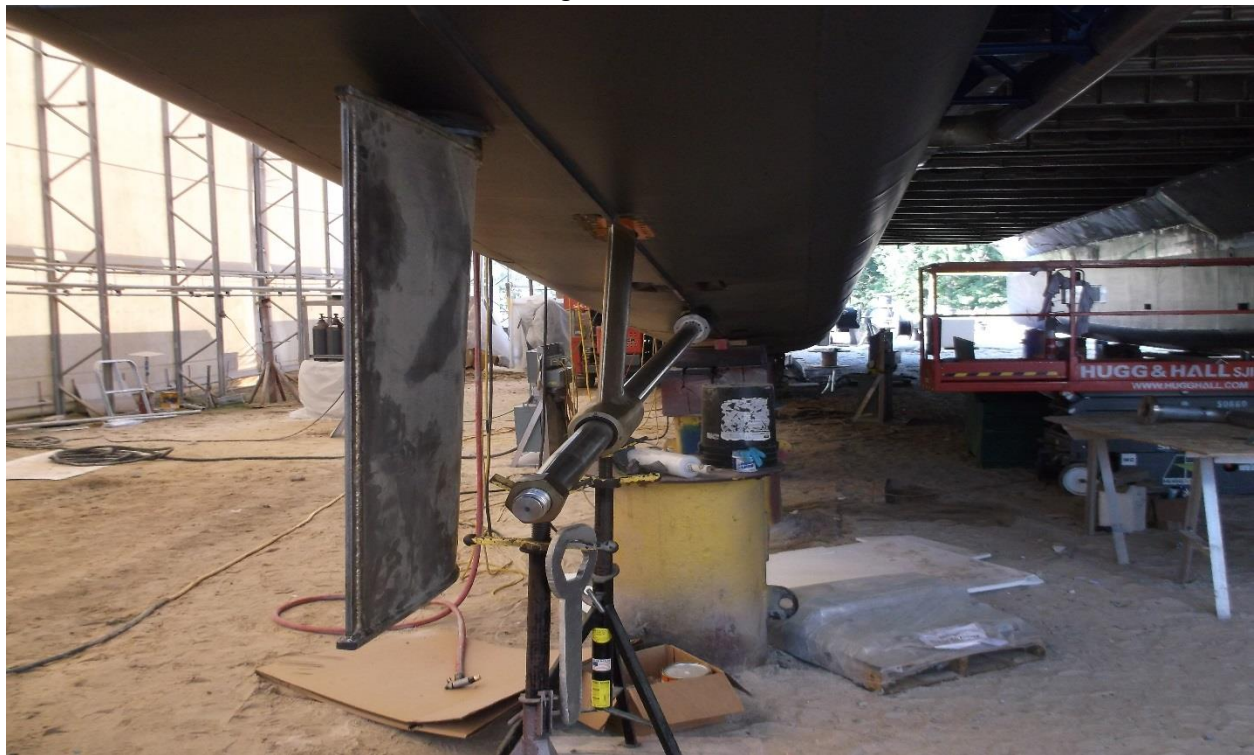
Close view of portside rudder, shaft and strut installed

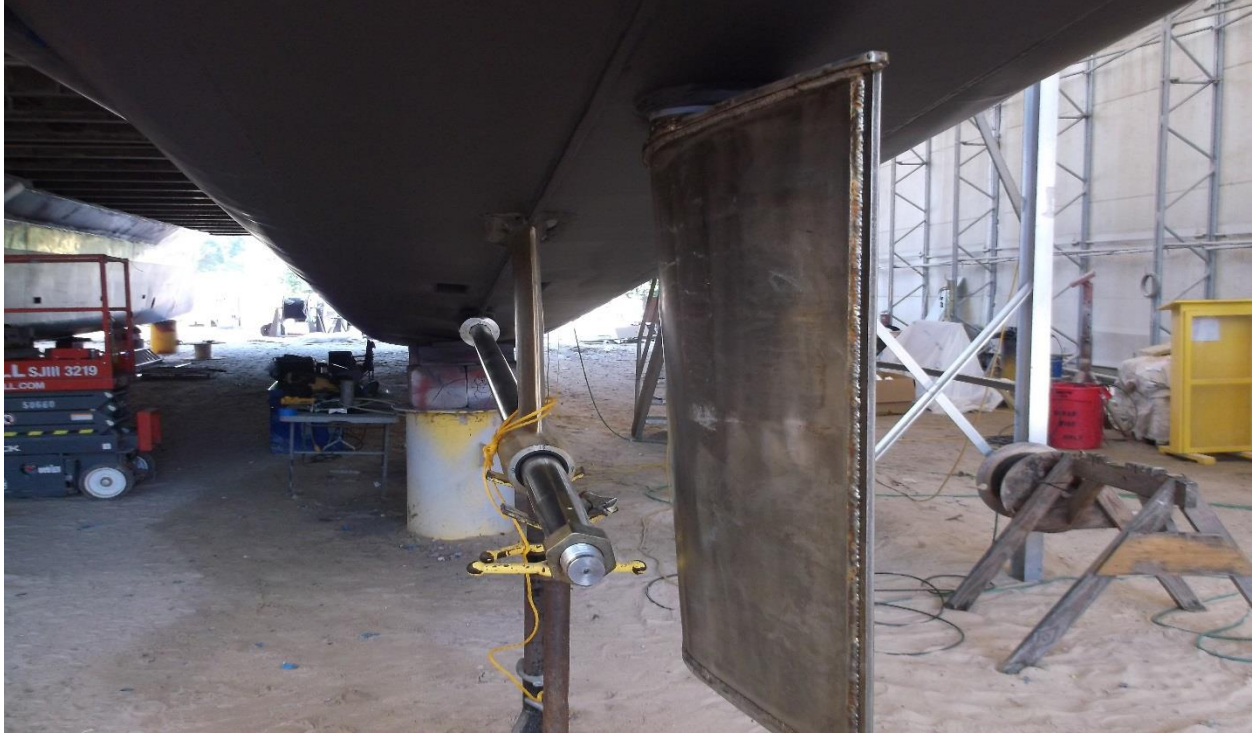
View of starboard rudder, shaft and strut installed

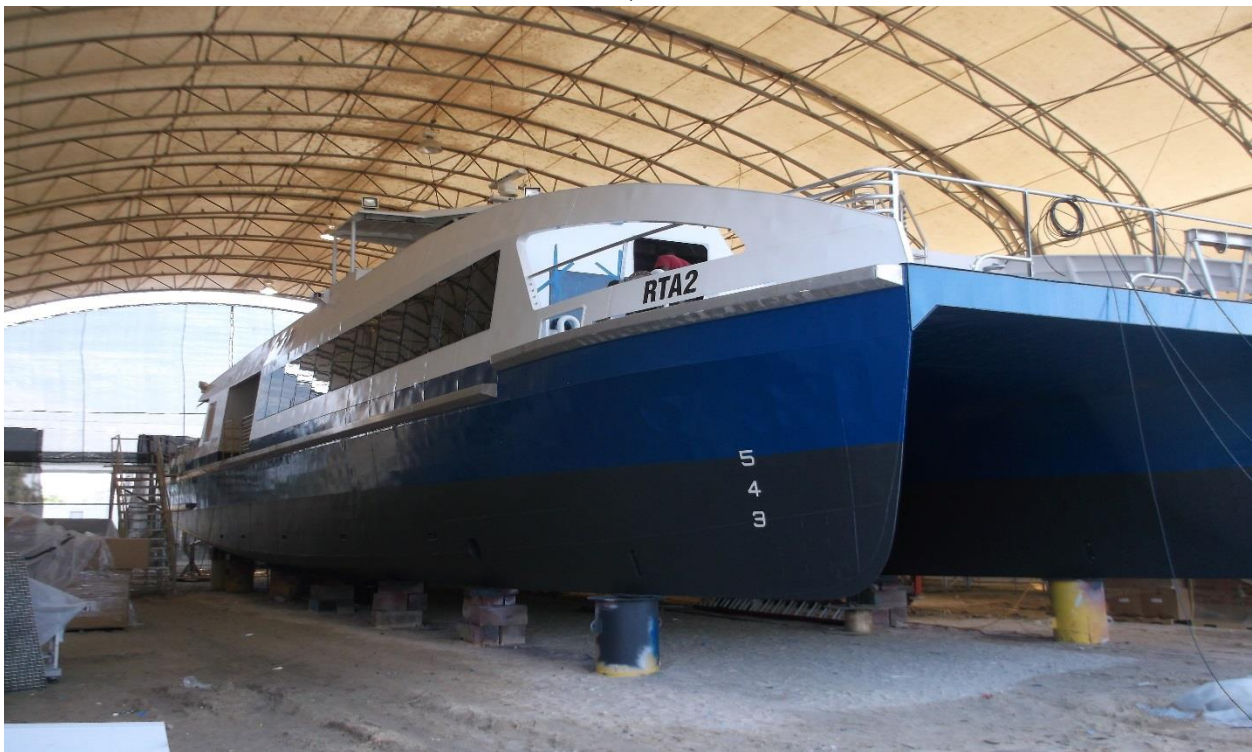
View from forward starboard side having windows installed on the deckhouse

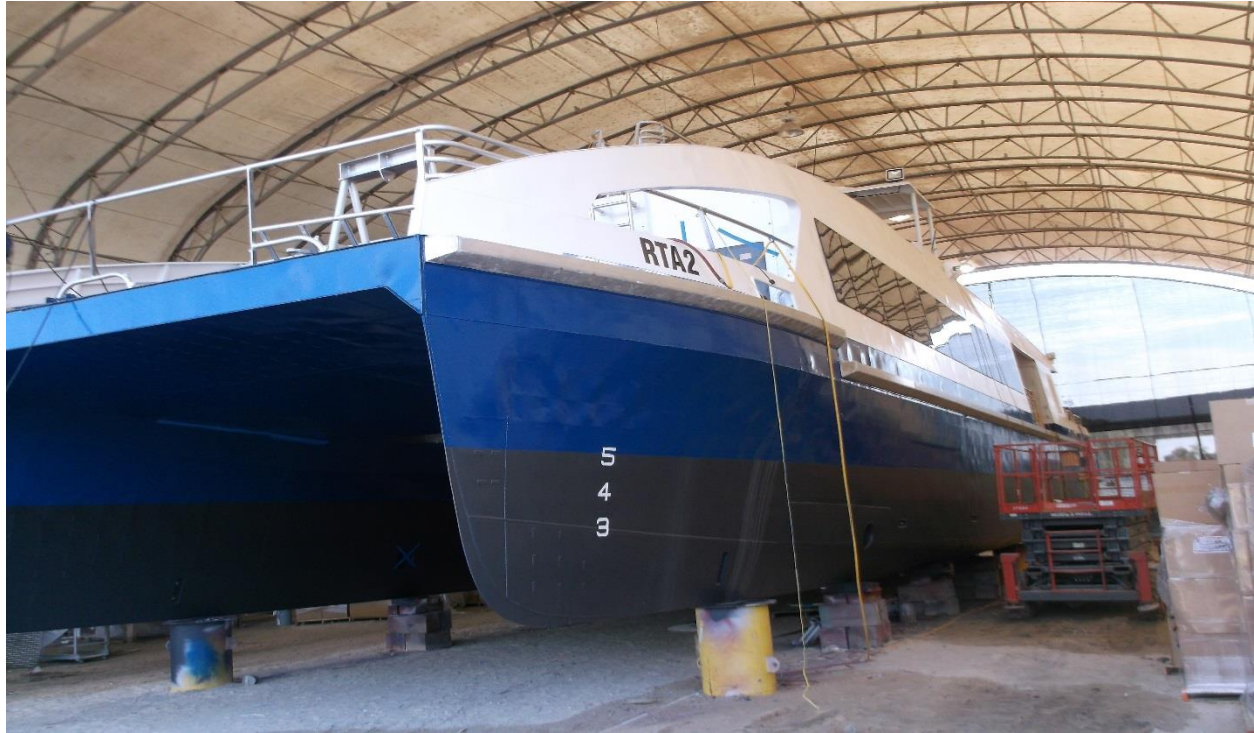
View from forward portside having windows installed in deckhouse

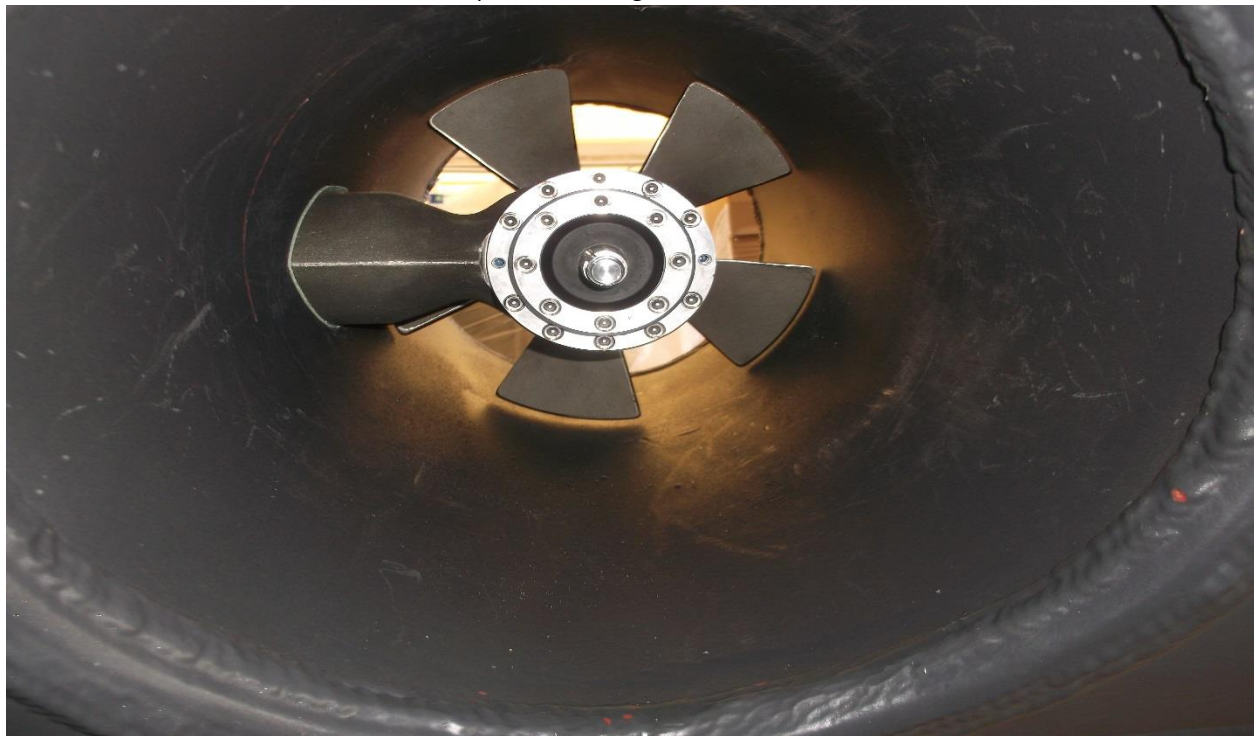
View of bow thruster unit installed with outboard propeller installed

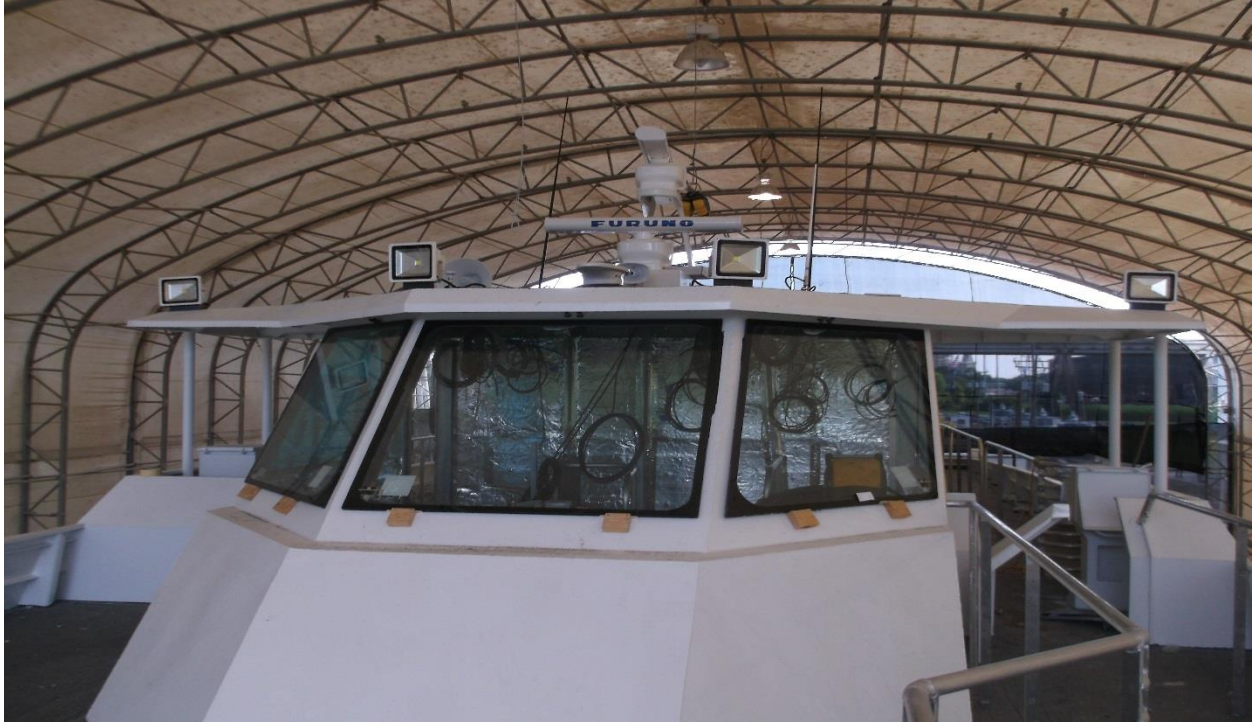
View of pilothouse having window glass, radar screens and whip radio antennas installed

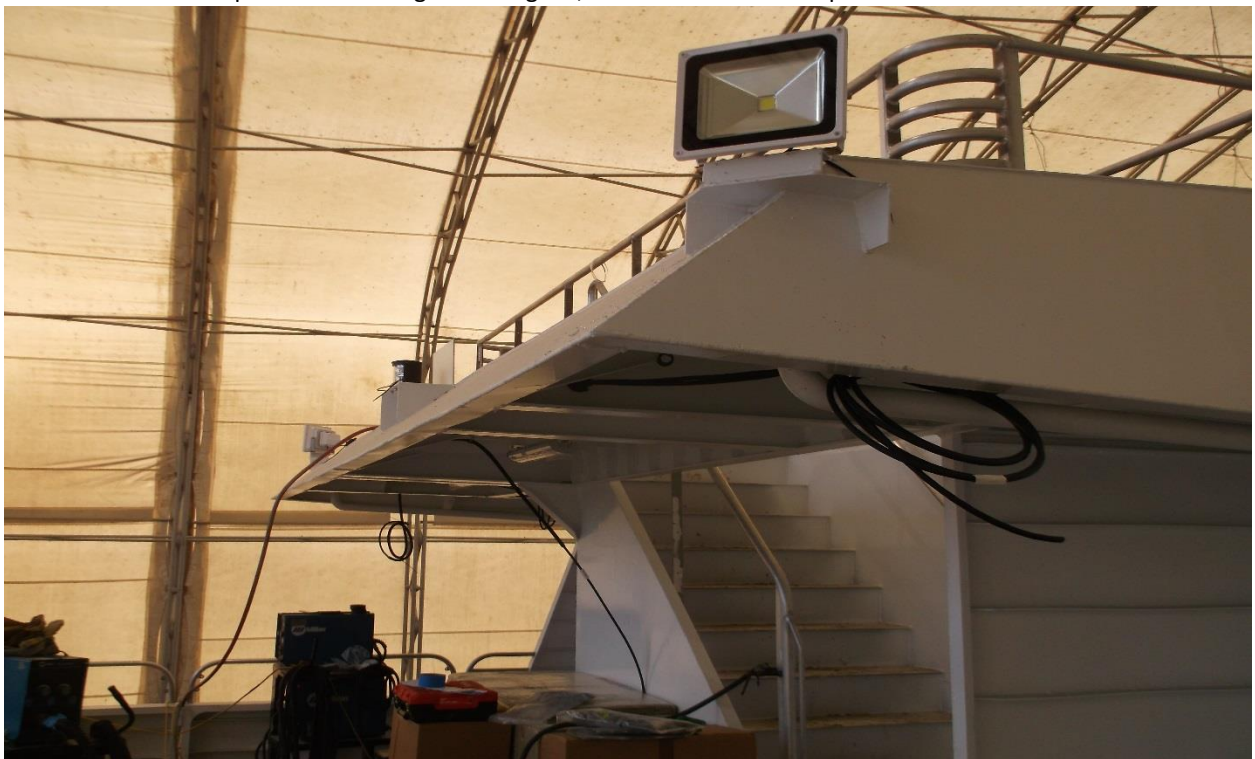
Aft main deck having floodlights and overhead florescent lights fixtures installed

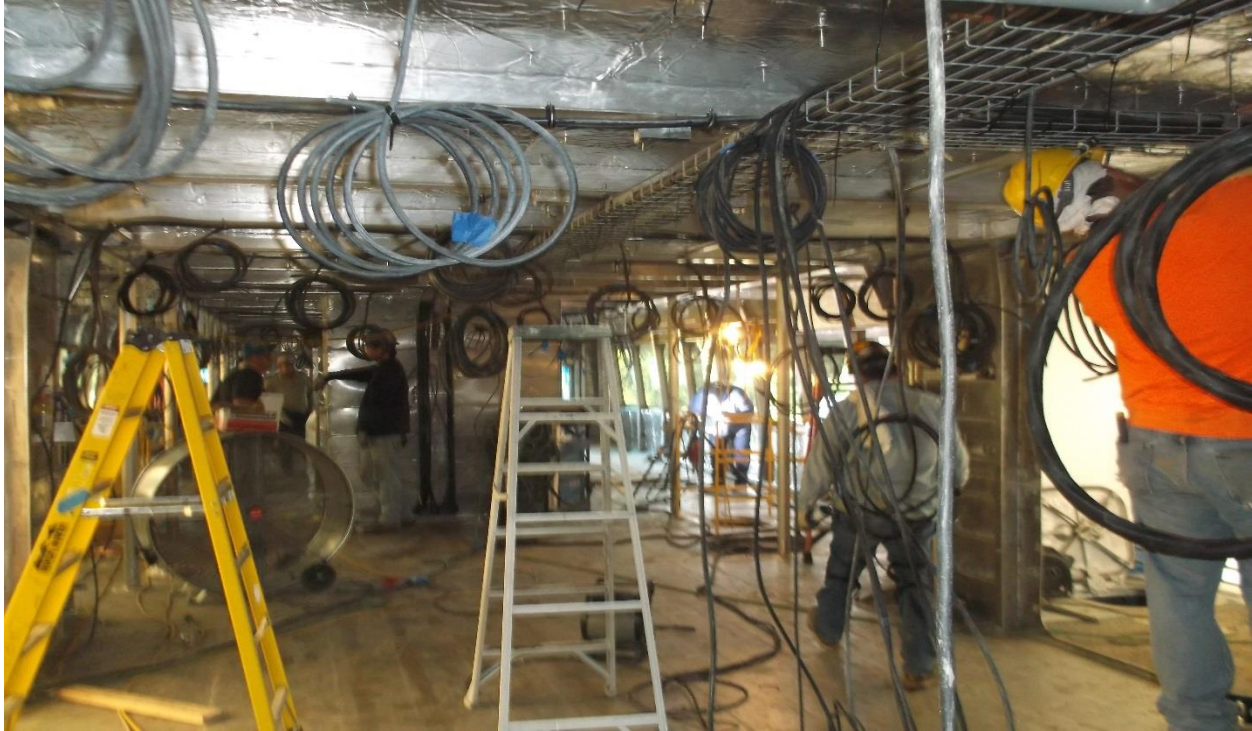
View looking forward inside aft deckhouse with electrical cables installing

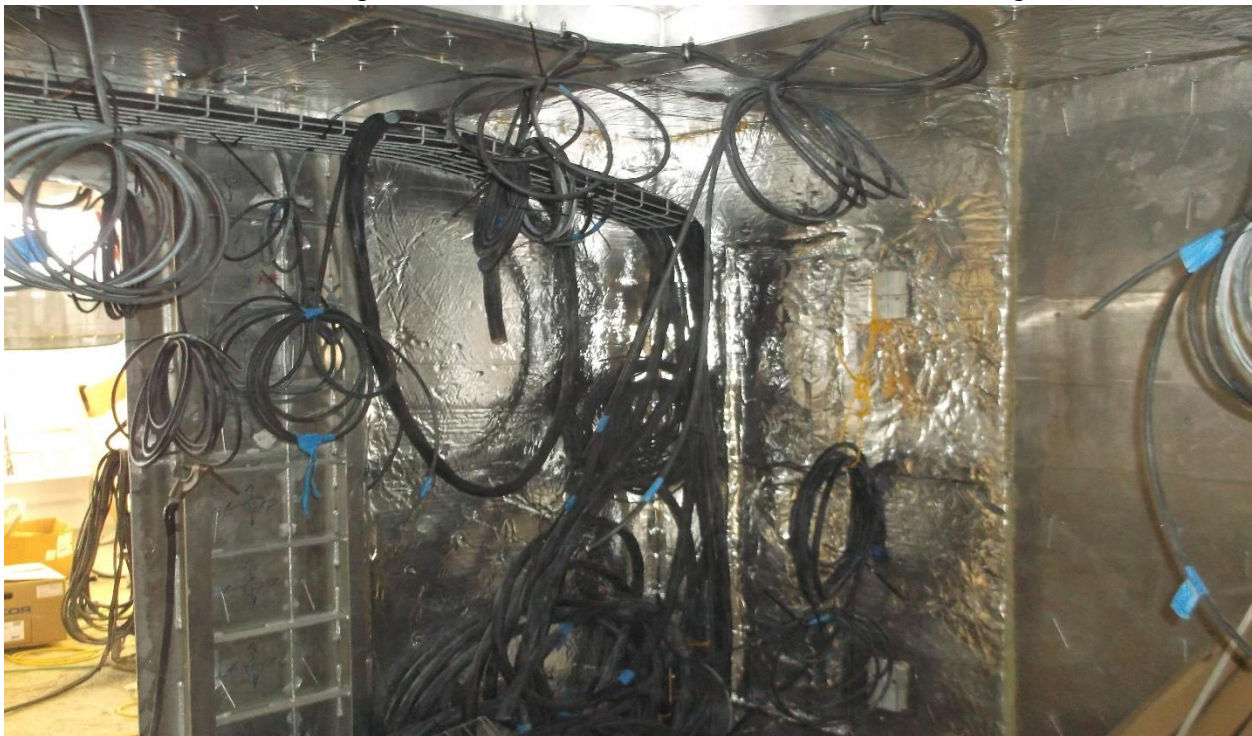
View of aft deckhouse portside corner, area of where electrical switchgear will be located

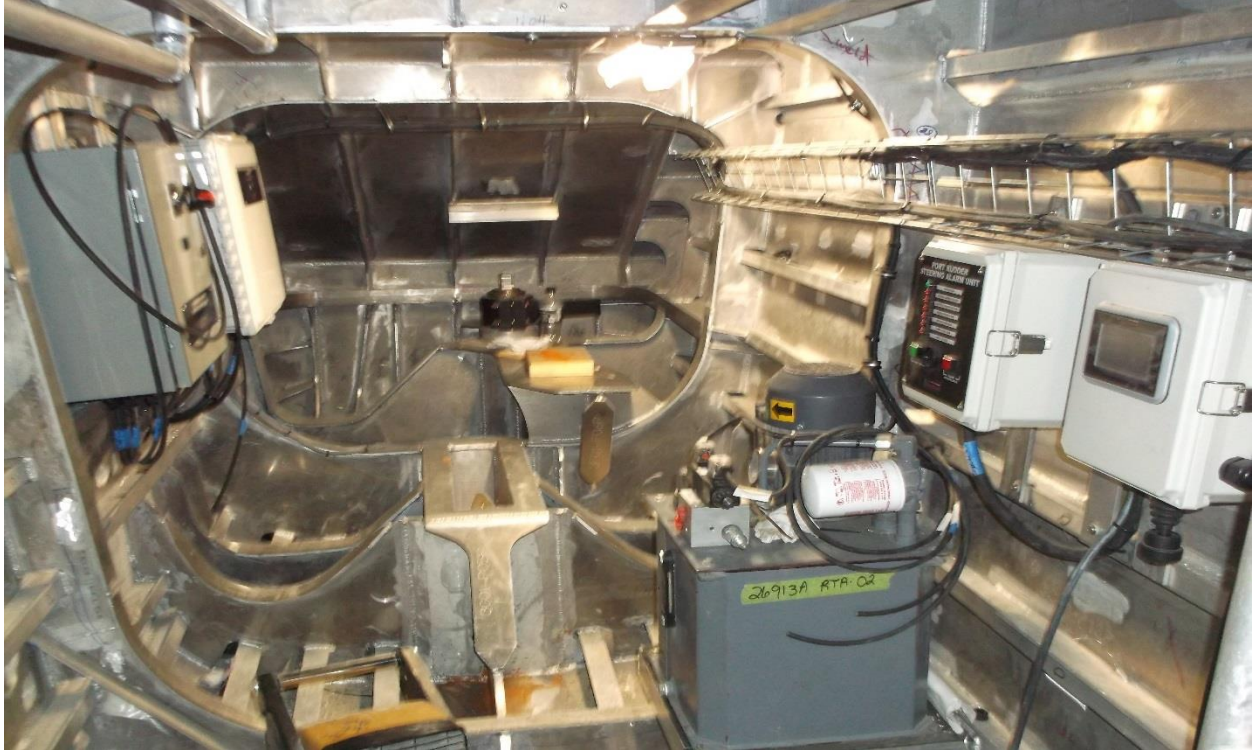
View inside no.5 portside compartment with steering components and electrical panels installing

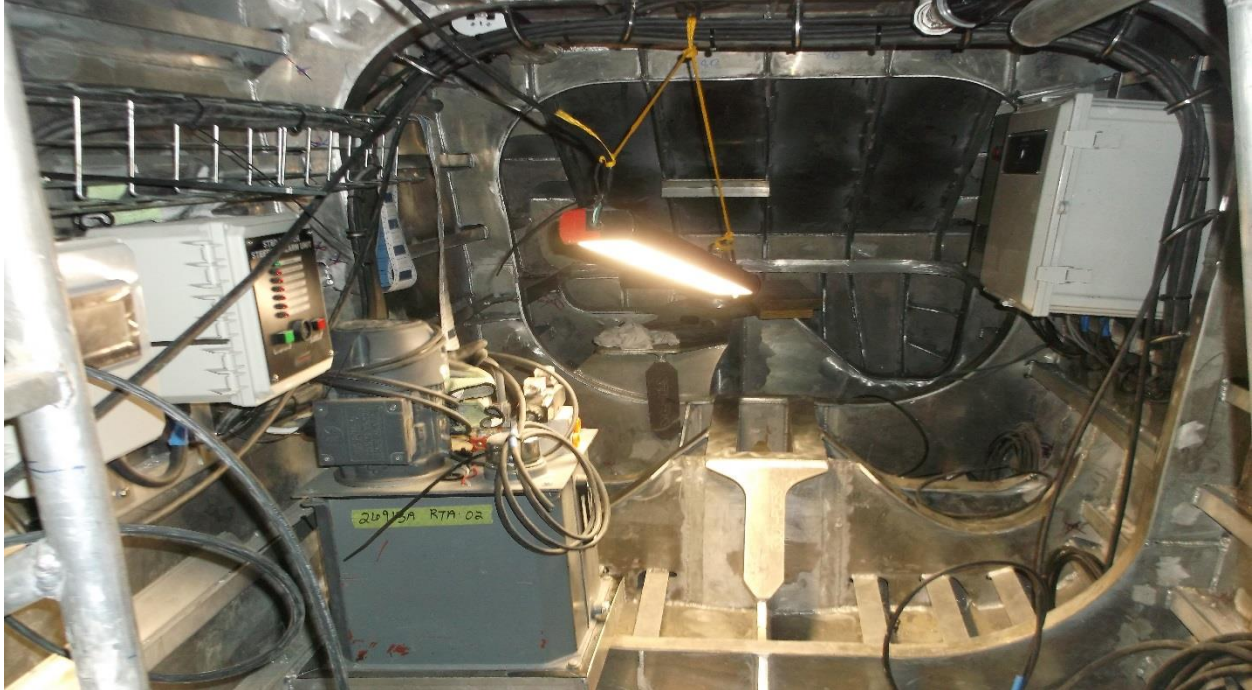
View inside no.5 starboard compartment having hydraulic steering pump and electrical panels and cables installed

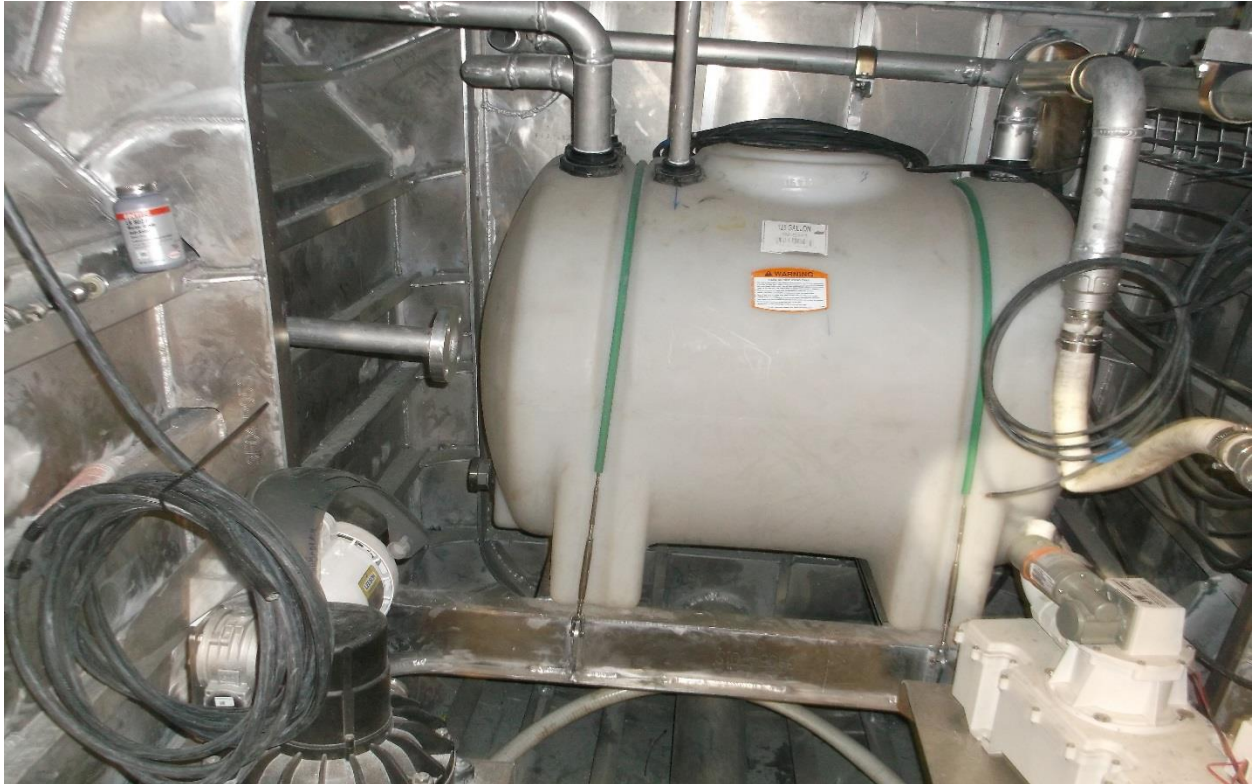
Forward view of above photo having gray-water tank piping in with pumps placed for installation

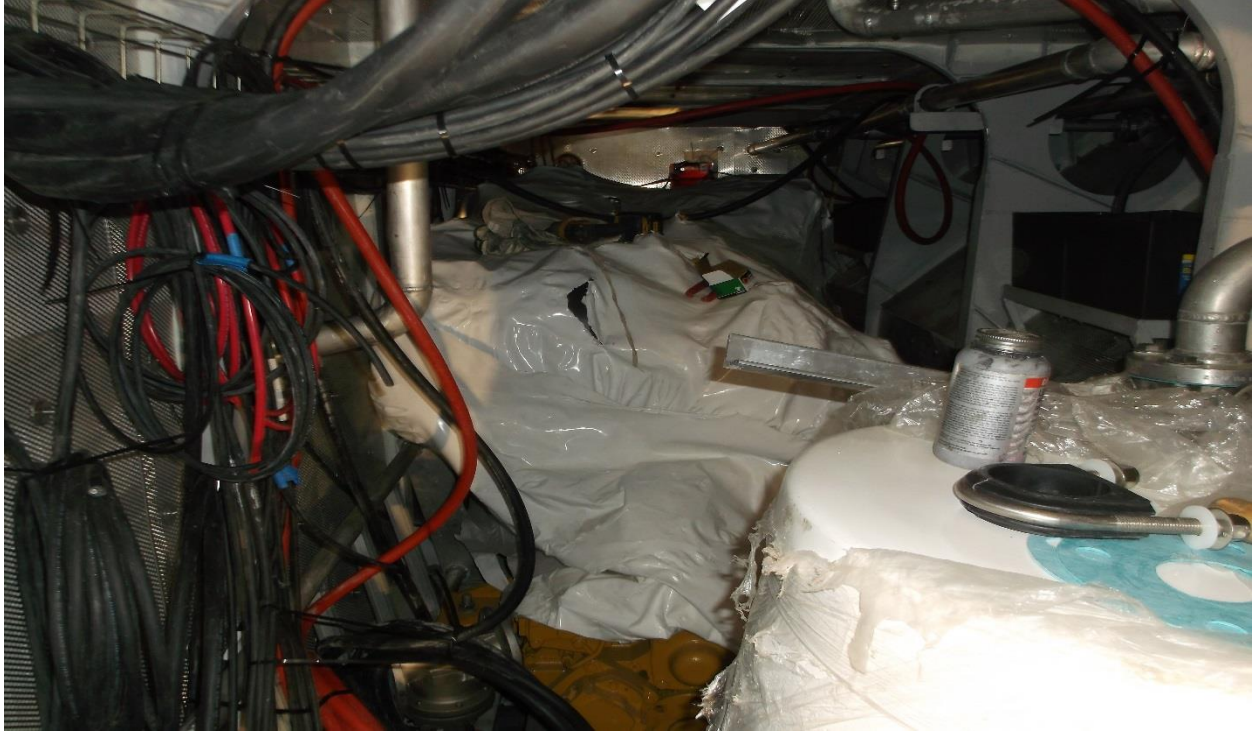
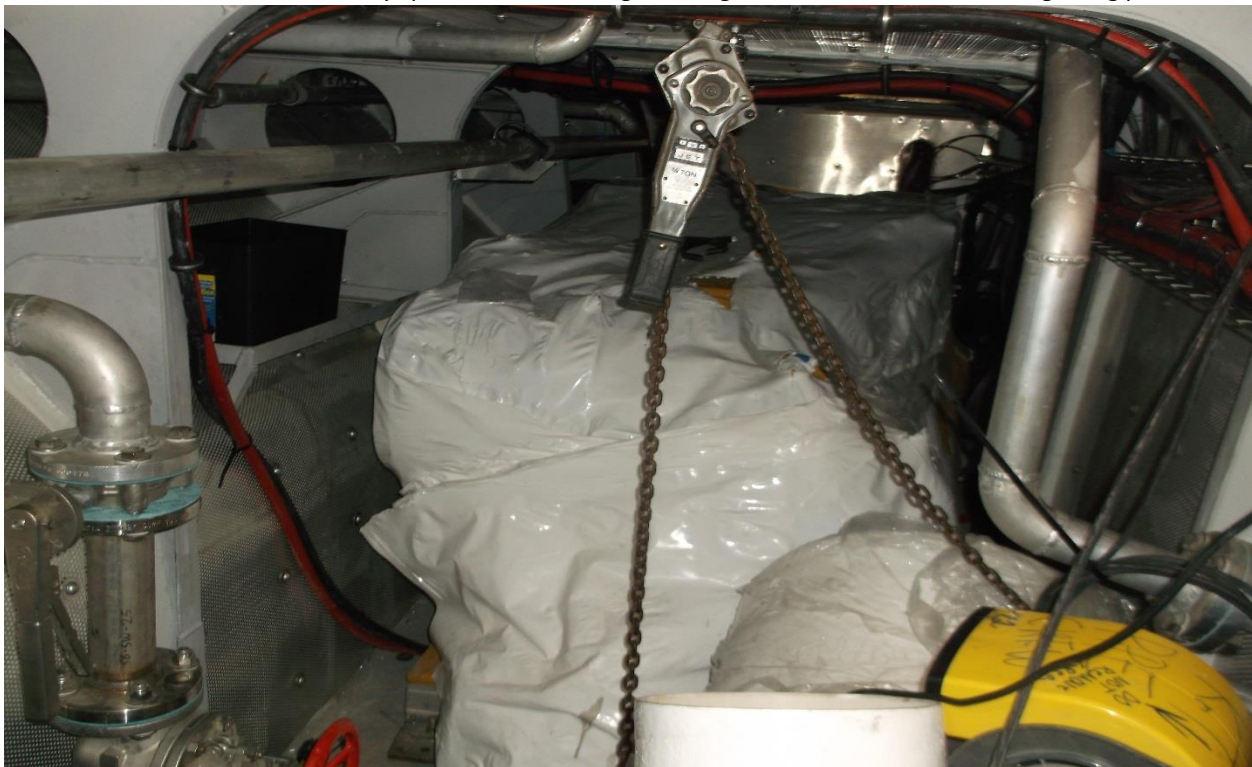
Aft views inside the machinery spaces with main engine and generator installed and cabling being pulled

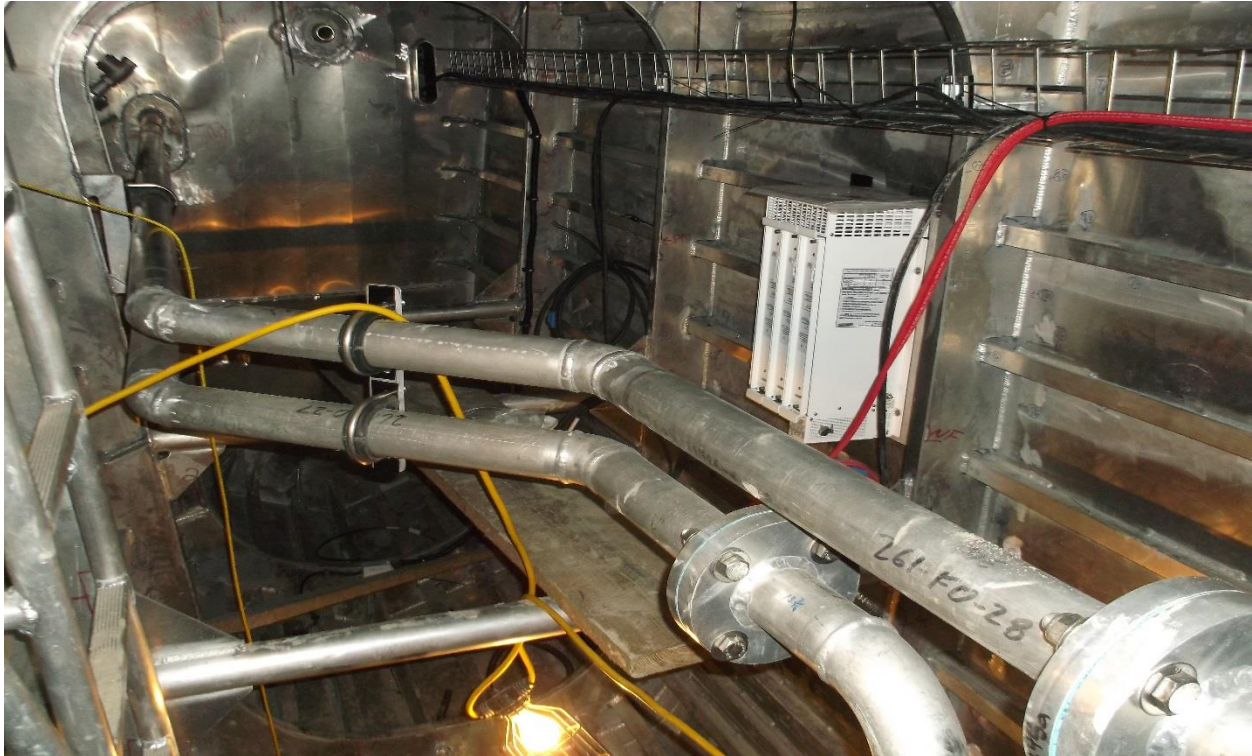
Stbd no.3 compartment having fuel oil supply and return piping installed to tank and electrical cabling installing

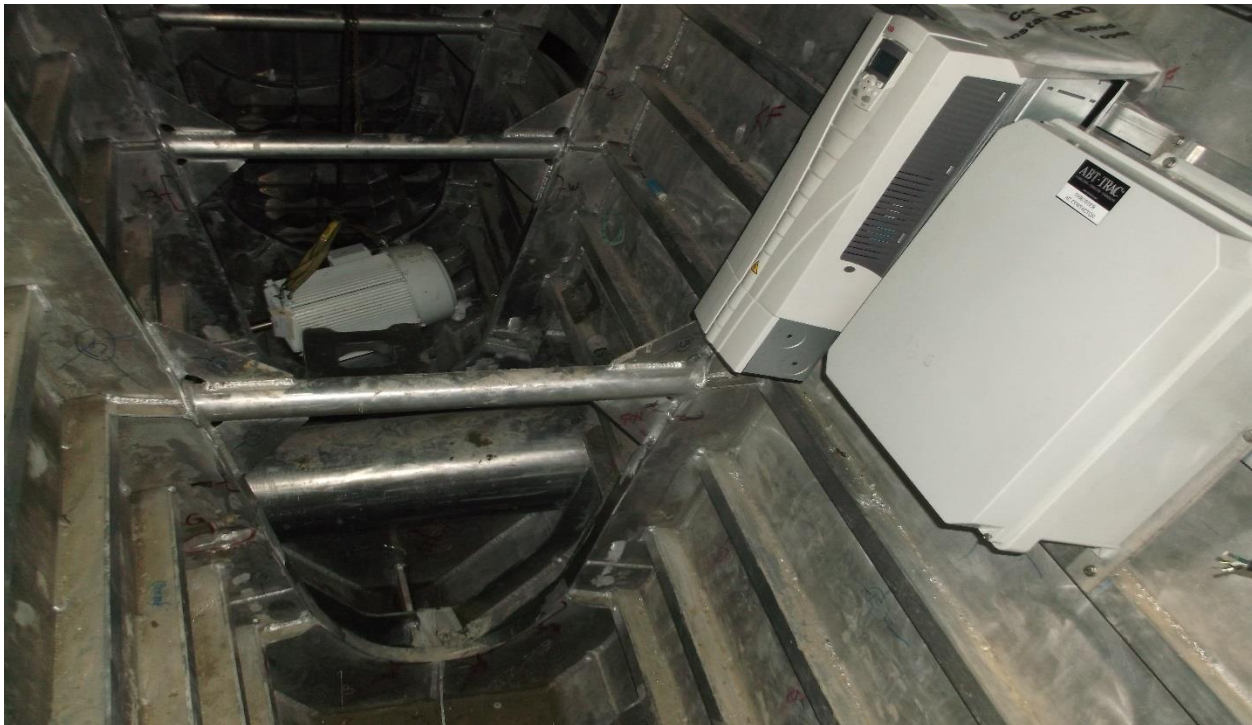
No.2 port compartment having electrical control panels, cables installing with bow thruster motor placed

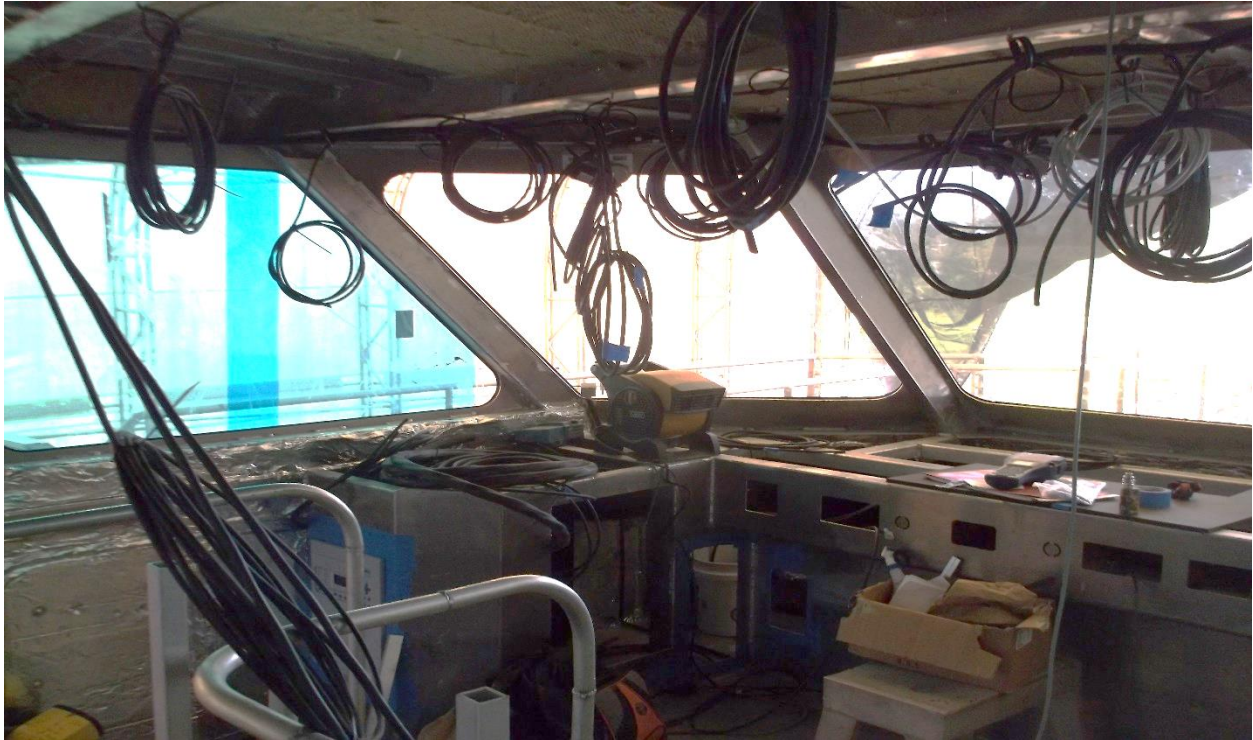
Forward and aft views inside pilothouse having electrical cabling pulled overhead and behind console

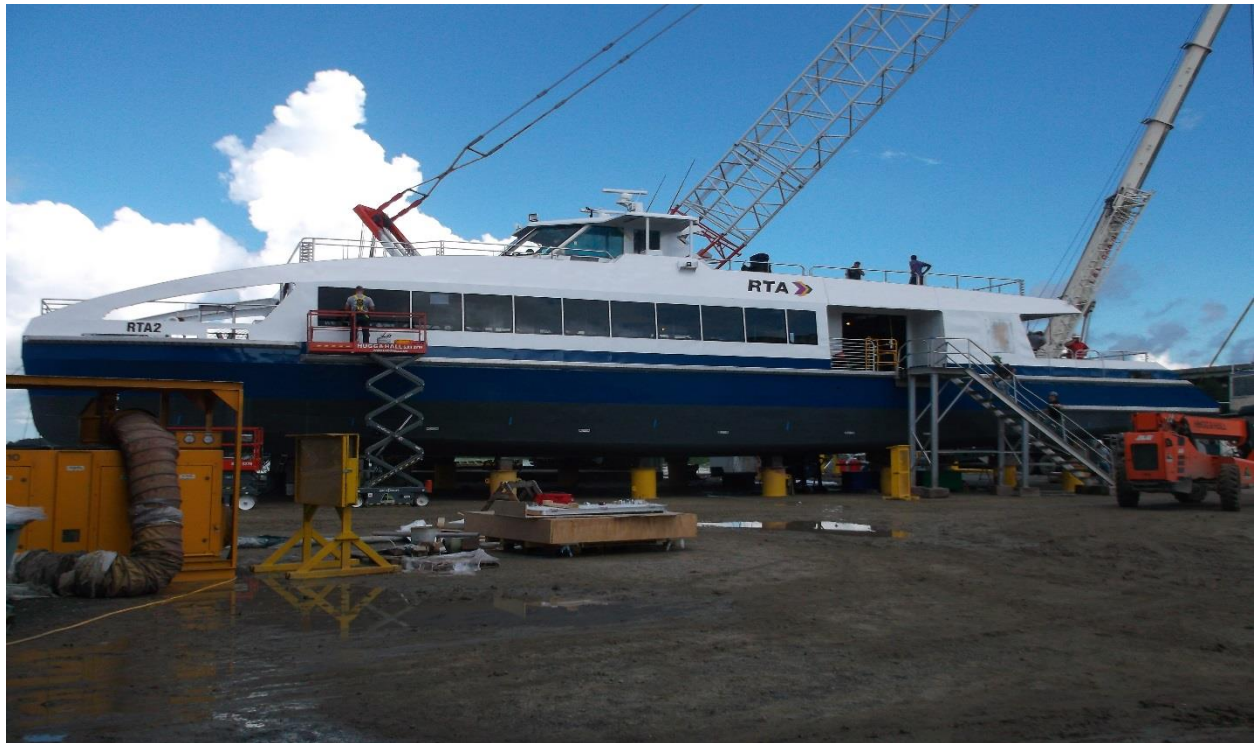
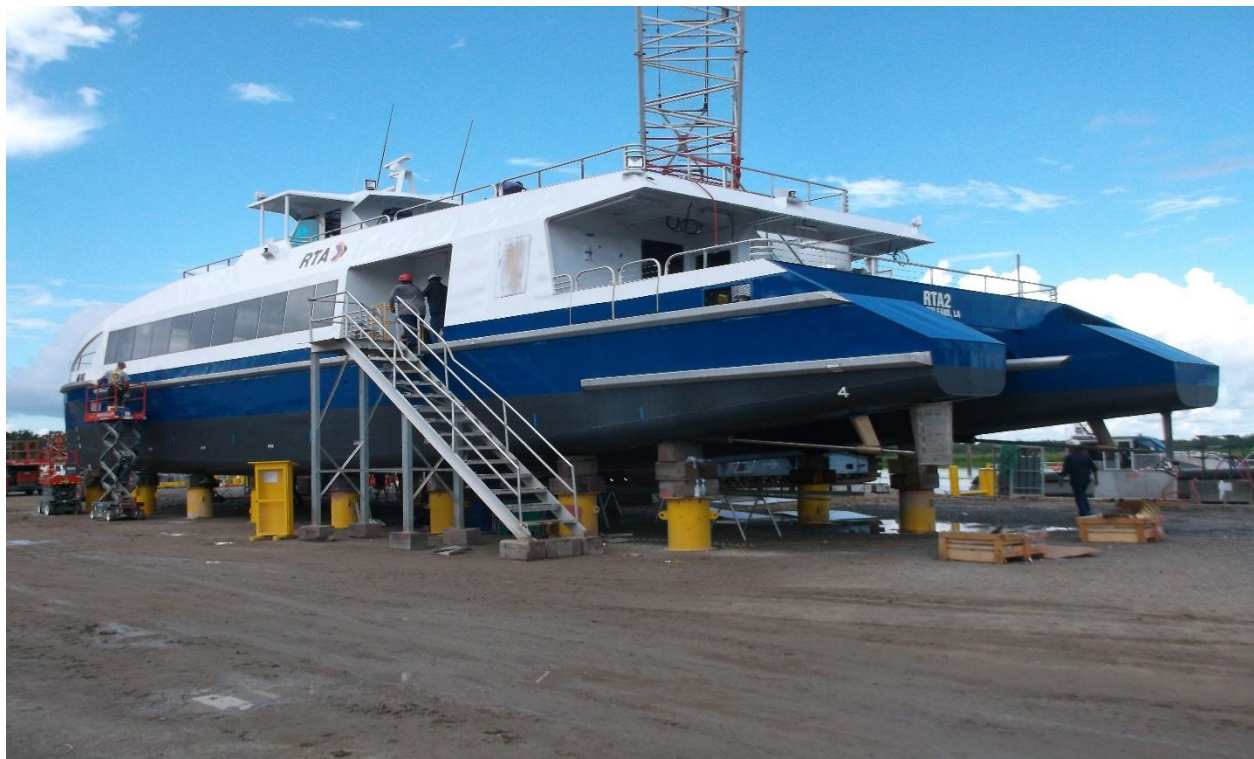
Port side views

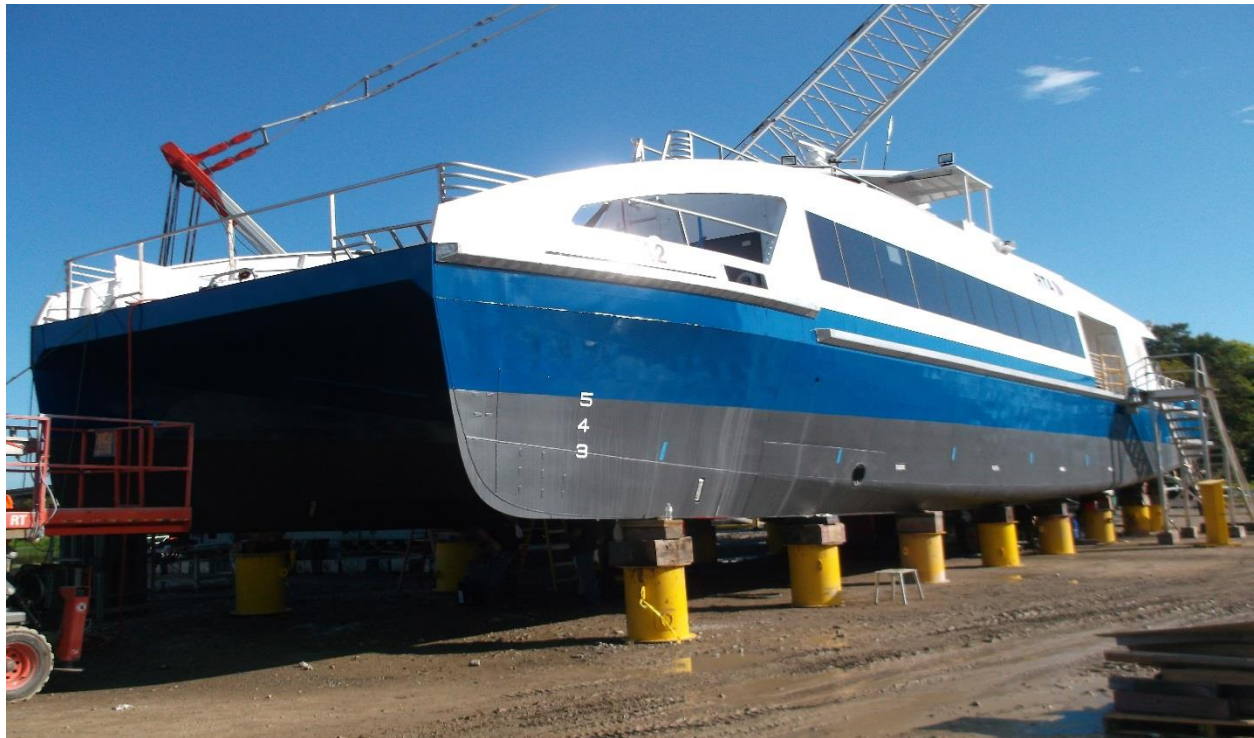
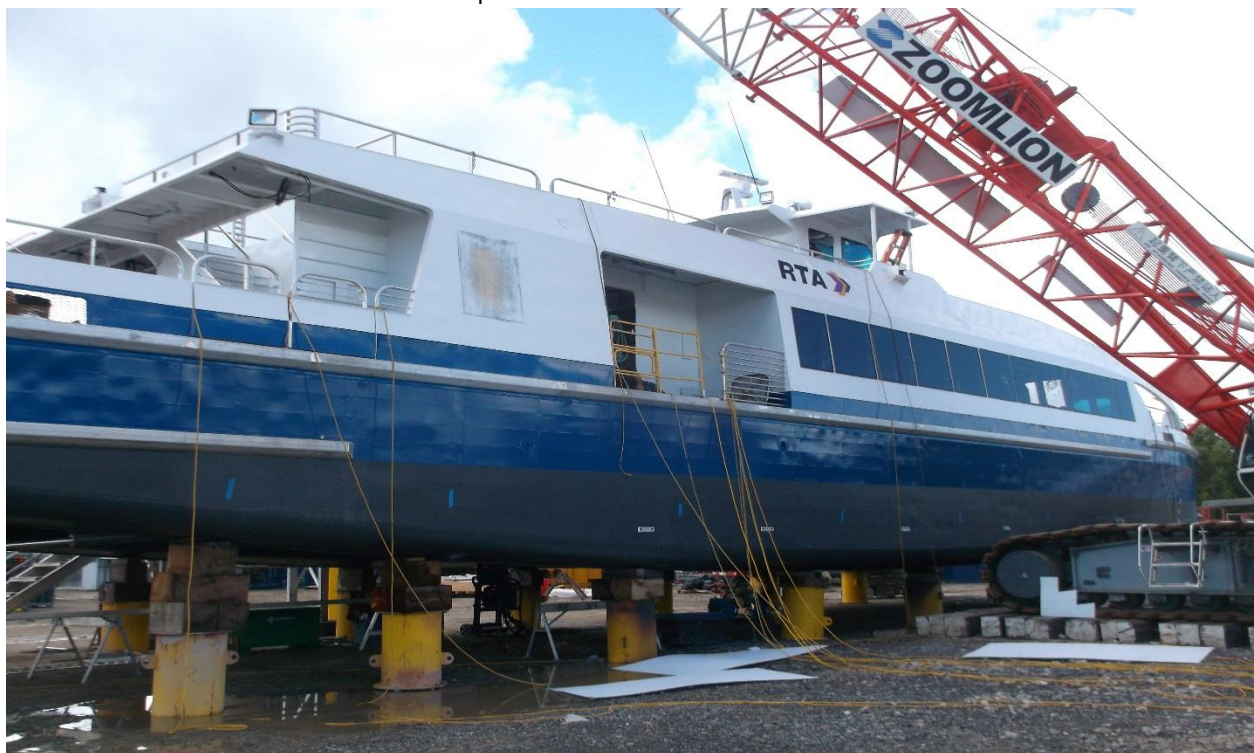
Forward portside and aft starboard side views

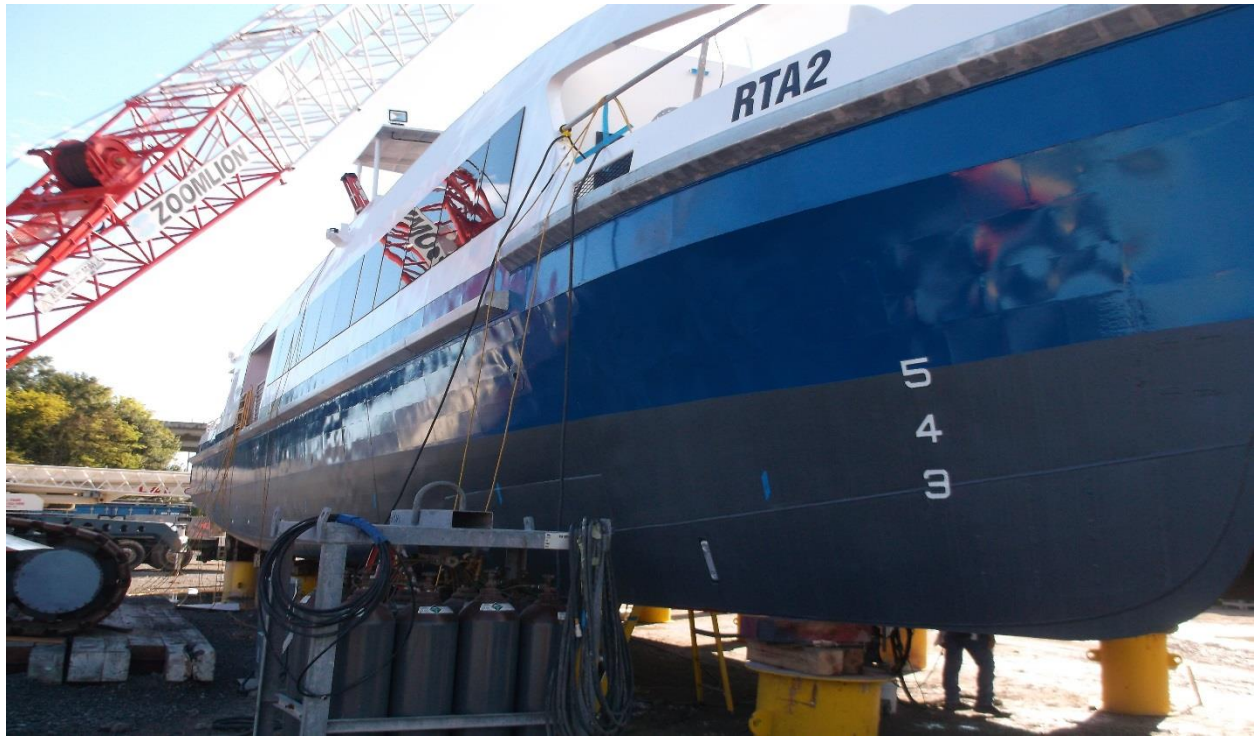
Starboard forward side
